# 737 GRAPHITE COMPOSITE FLIGHT SPOILER FLIGHT SERVICE EVALUATION

FIRST ANNUAL REPORT  
JULY 1973 THROUGH MARCH 1975

Prepared under contract NAS1-11668 by  
BOEING COMMERCIAL AIRPLANE COMPANY  
P.O. Box 3707  
Seattle, Washington 98124

May 1975

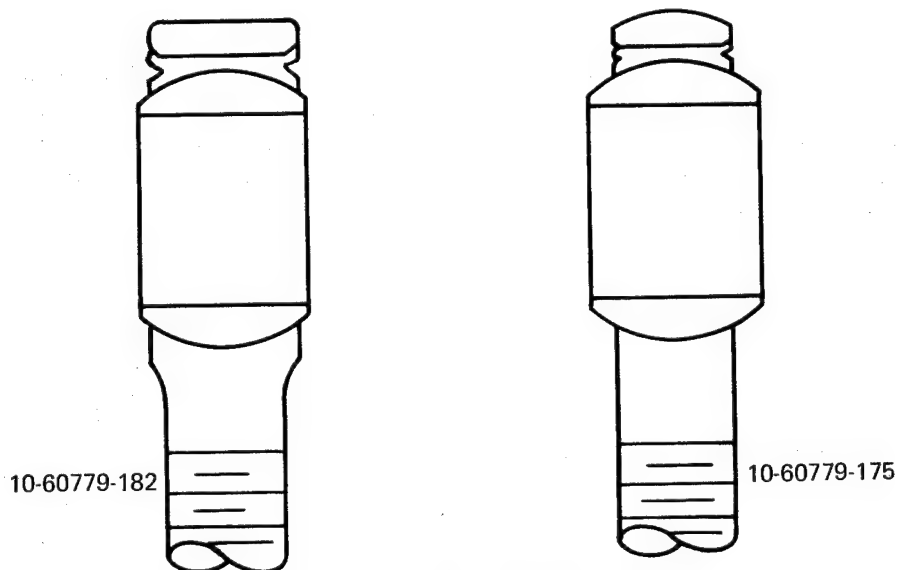
Figure 5.—Actuator Rod End Cross Sections

The most significant problem area has been the occurrence of upper surface skin blisters. This problem has been investigated and determined to be the result of an interference between the actuator rod end and the inner surface of the upper skin, when the rod end is in the "hard-over" position. Since the graphite skin is thicker,  $\approx 0.091$  vs  $0.081$  cm ( $\approx 0.036$  vs  $0.032$  in.), and stiffer than its counterpart on the production aluminum spoiler, the graphite skin cannot accept the forced deflection without suffering an interlaminar shear failure. This type of problem was first noted in October 1973 on an Aloha 737. After the third such incident was reported in July 1974, a fleet survey of Aloha was conducted by the program technical leader. This survey disclosed six additional spoiler blisters not previously reported. Discovery of the rod-end interference problem led to a program-wide survey of all participating airlines to assess the extent of blister damage. This survey (October through November) disclosed three additional blistered spoilers on aircraft of two of the other airlines.

The immediate corrective action available was to replace the offending rod ends with the optional rod end which offers a spherical housing configuration (fig. 5). Replacement rod ends were furnished to Aloha, and rod ends for the remaining airlines were distributed during the January 1975 inspection tour.

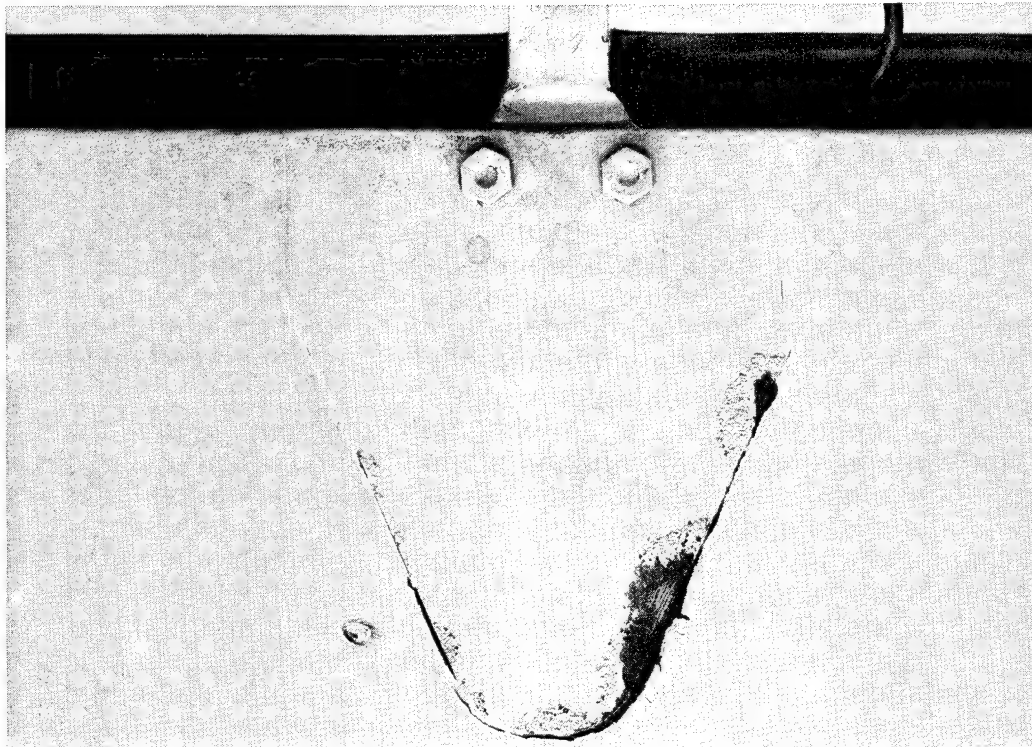
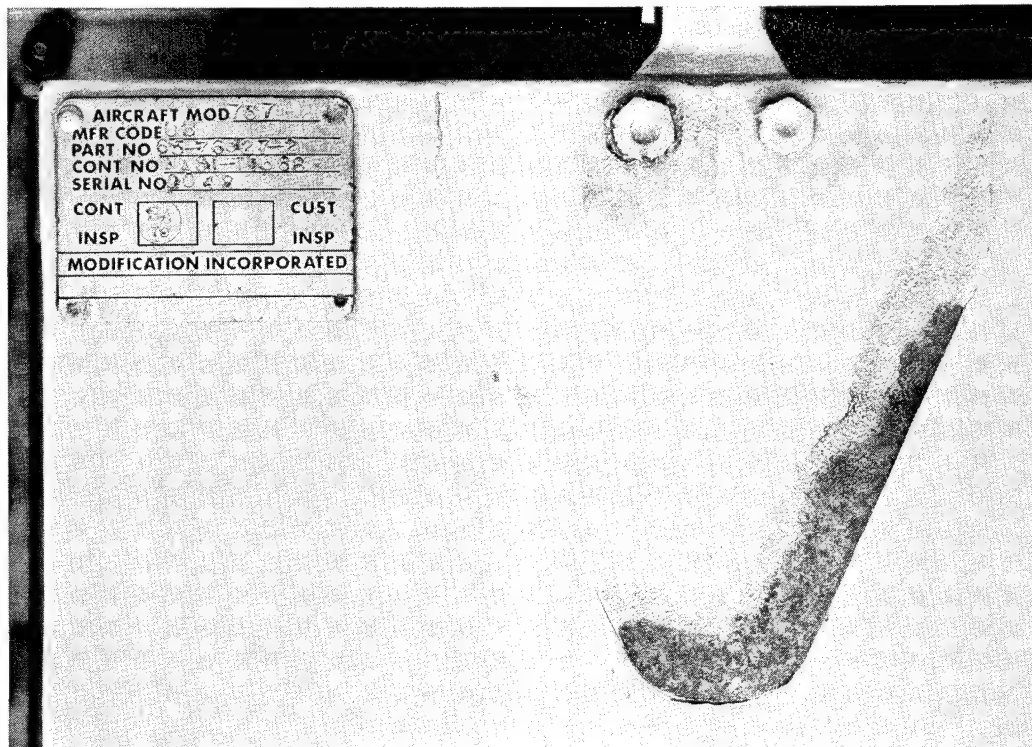
Figure 6.—Corrosion on -23 Doubler

the laminates points out very clearly that extreme caution must be exercised to avoid undesired forced displacements of the laminates. No evidence of corrosion or deterioration of the skin laminates has been observed. One case of corrosion of the aluminum bearing doublers on the spoiler lower skin was observed (spoiler S/N 0048, fig. 6). Investigation of this condition is continuing.

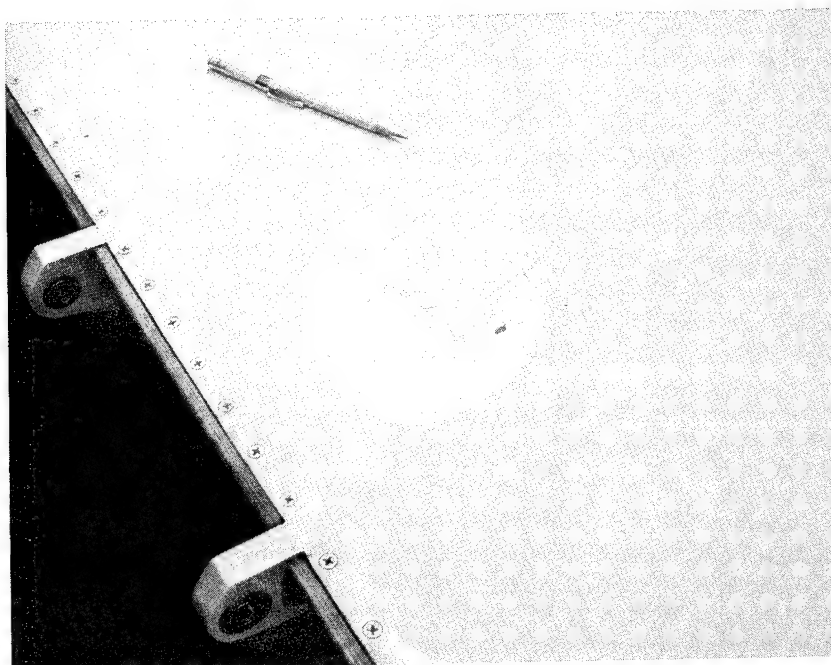
*Figure 7.--Upper Surface Repair Delamination on S/N 0014*

Five spoilers were selected at random for removal following the first year of service. Visual inspection of these units showed no detectable defects and only the oil and dirt associated with trailing edge components, except for spoilers S/N 0014 and 0104. Spoiler S/N 0014 showed evidence of delamination of a repair on the upper surface skin above the center hinge fitting (fig. 7). Spoiler S/N 0104 showed an upper surface skin blister, approximately 3 cm (1.2 in.) in diameter, above the center hinge fitting (CHF), which was not repaired prior to its destruction in static test.

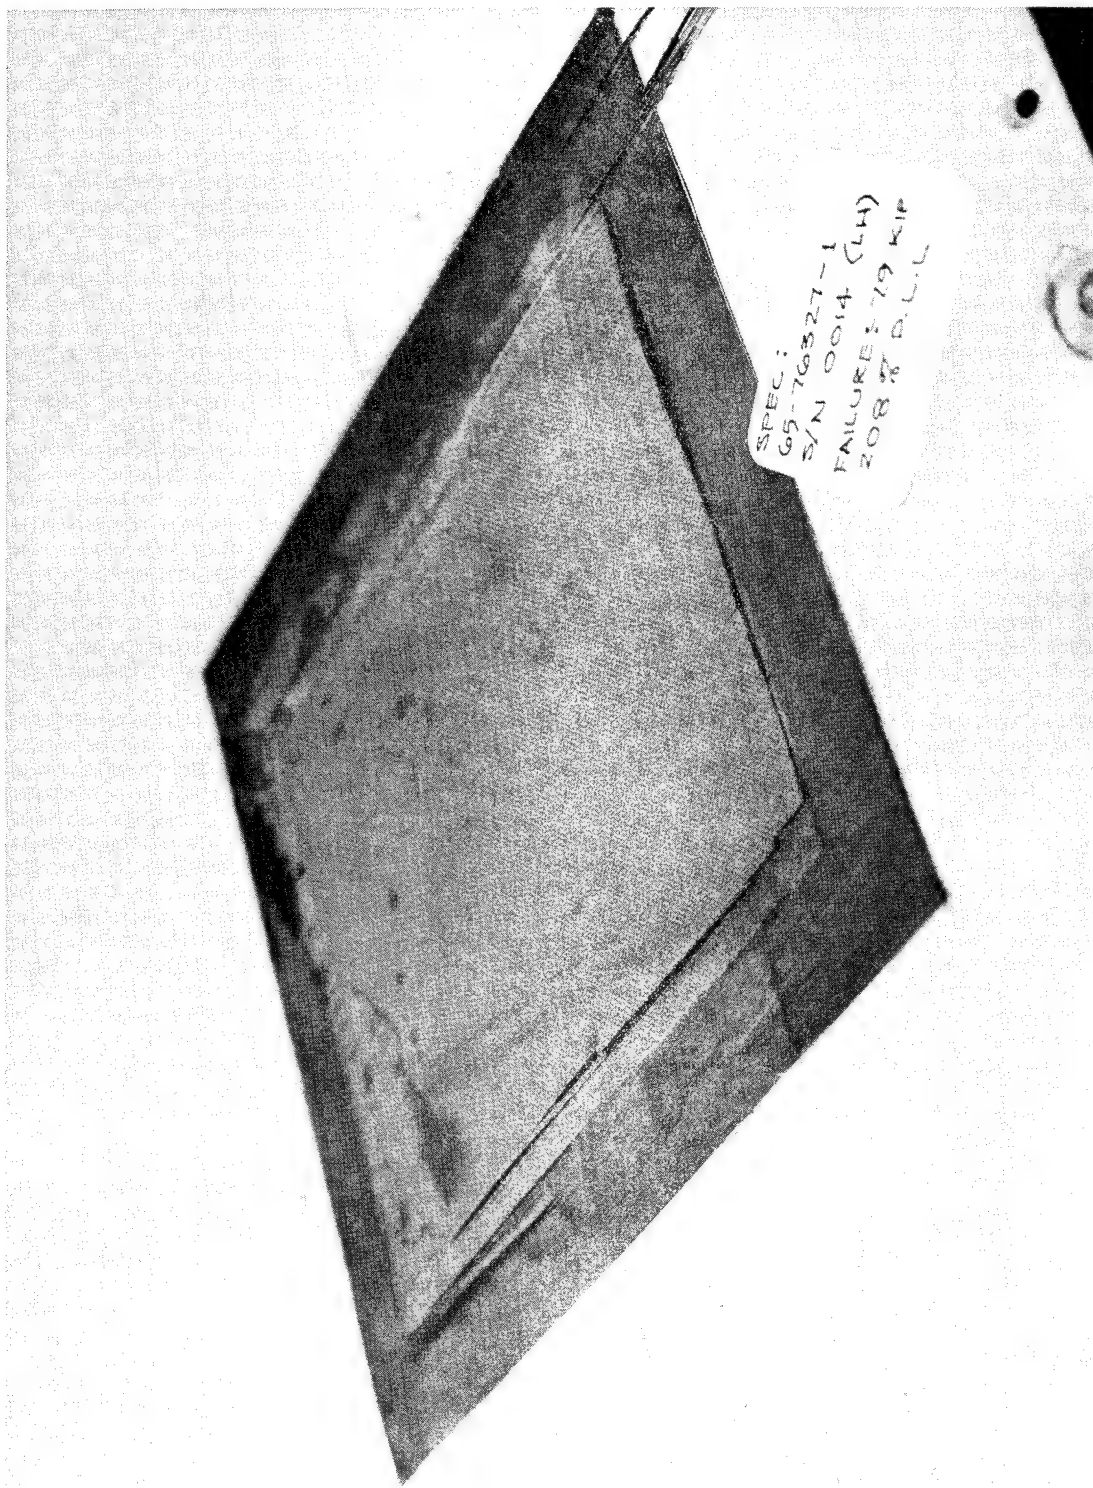
1. Initial failure of S/N 0014 was brought about by the combination of shearing of the -11 aluminum doubler above the CHF and failure of the repair patch on the upper skin above the CHF. The failure load achieved was attained despite a "resin only" joint around the edges of the repair. Repair procedures have been modified to include EA 9628 adhesive in the repair lap joints. Although the failure occurred in the skin repair area, the percentage loss in failure load was essentially no greater than for the other two test specimens. Failure of the comparable certification test spoiler (S/N 0002) was attributable to lower surface skin buckling near the CHF due to deflection of the CHF.

Figure 11.—Failure of S/N 0014 Through Repair

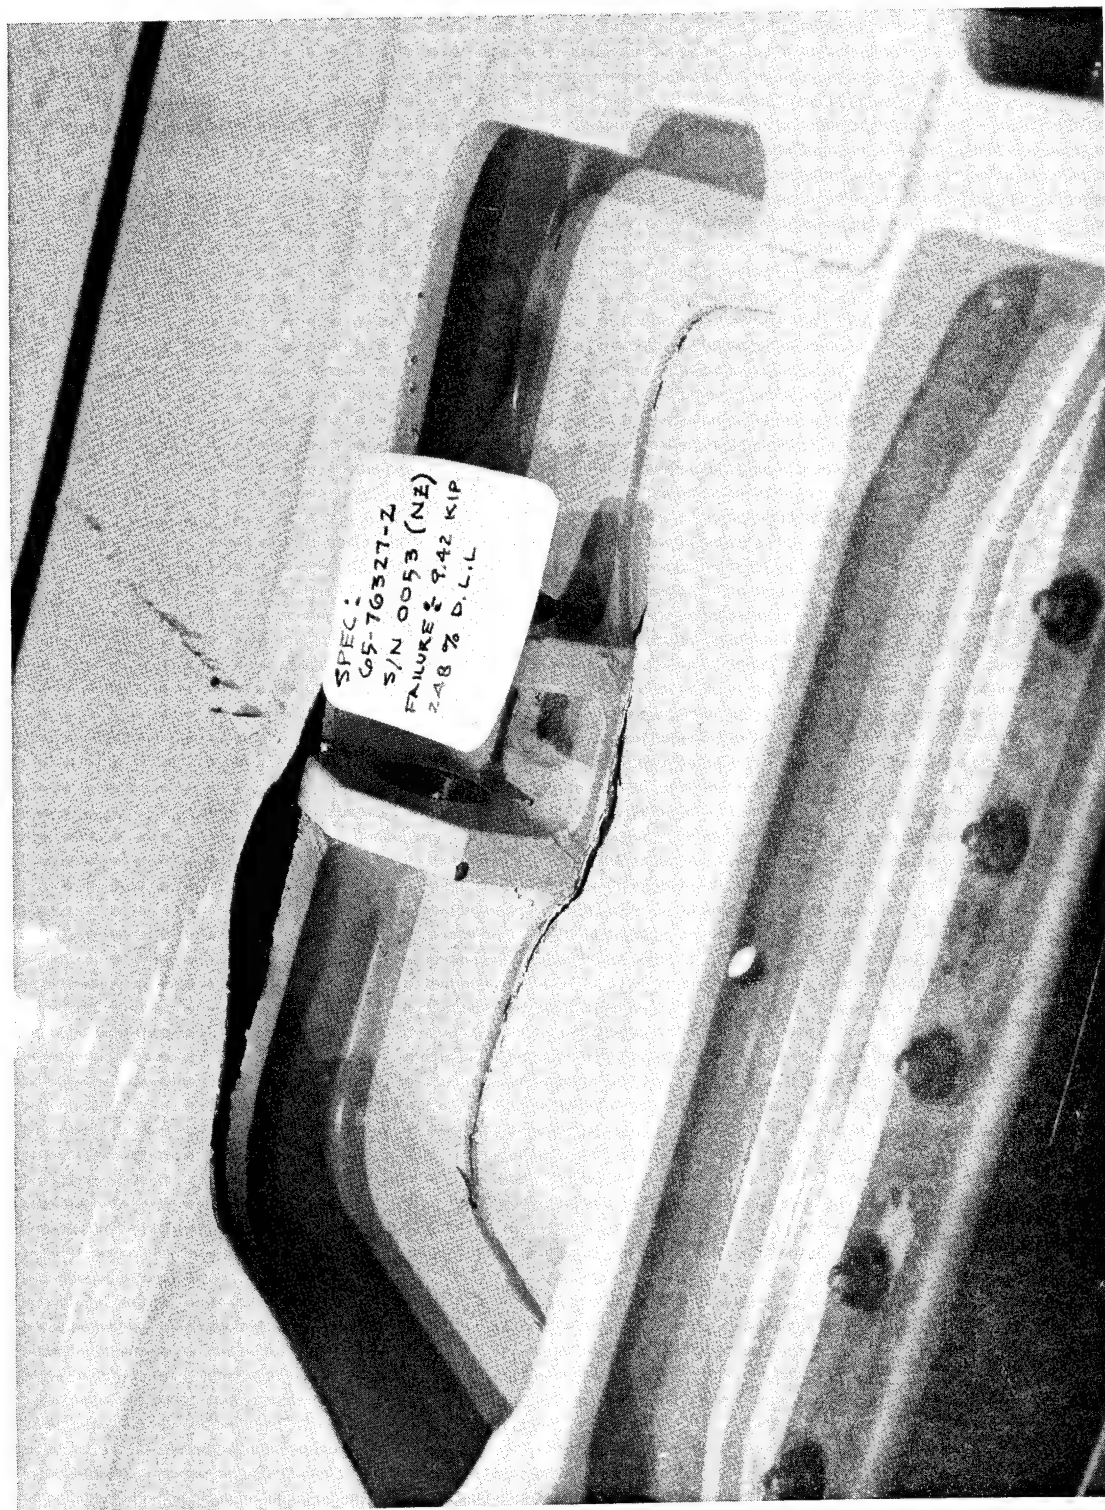
2. Failure mode of the T300/5209 spoiler (S/N 0053) has been assessed as a primary lower skin buckling immediately adjacent to the CHF. An additional failure of the -11 aluminum doubler under the upper skin precipitated the upper skin tension failure. Both failures were influenced by deflection of the CHF. Failure of the comparable certification test spoiler (S/N 0041) was attributed to upper surface skin tension failure precipitated by yielding and failure of the CHF.

Figure 12.—Failure of S/N 0053 Above and Below Center Hinge Fitting

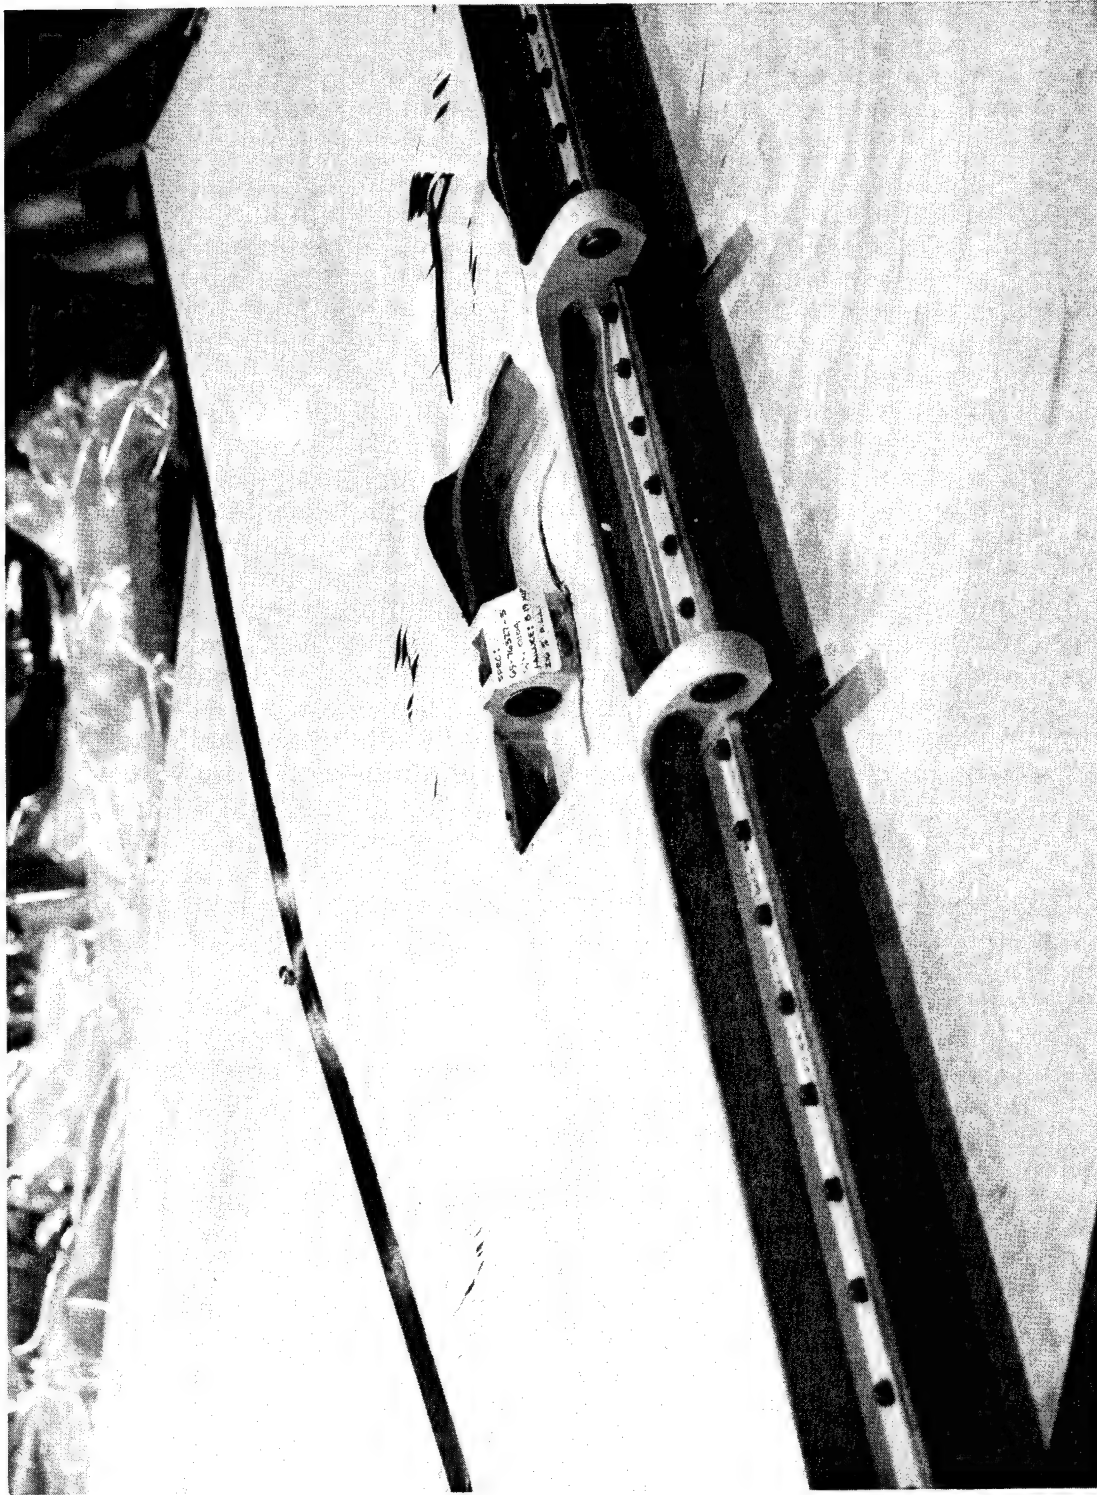
3. Failure mode of the AS/3501 spoiler (S/N 0104) was indicative of a shear failure in the bondline between the honeycomb core and the CHF, with secondary shear failure in the honeycomb core along the spoiler centerline. The comparable certification test spoiler (S/N 0081) failed in buckling of the lower skin near the CHF, with a resulting honeycomb core shear failure along the spoiler centerline.

Figure 13. —Failure of S/N 0104 Adjacent to Center Hinge Fitting .

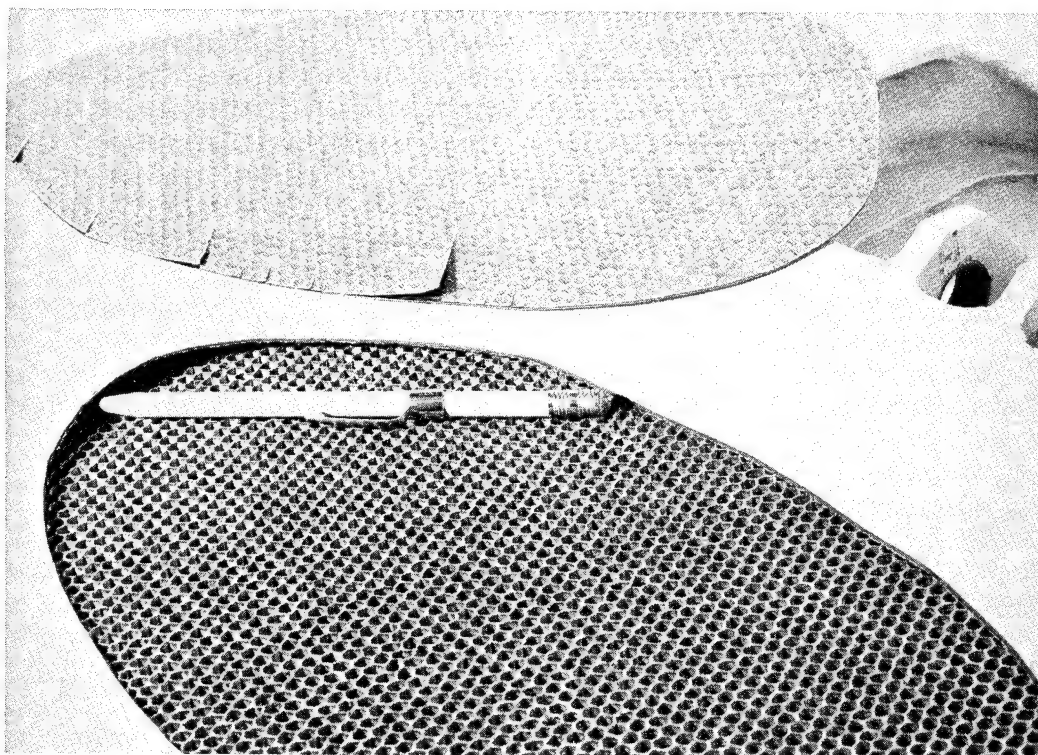
In one instance (S/N 0024), the spoiler, with the upper skin repaired, was not placed in the bonding assembly tool. Instead, a partial bag was prepared covering the repair only. Following autoclave cure and bag removal, a large oval-shaped void, approximately 20 x 30 cm (7.8 x 11.7 in.), was visually noted in the central portion of the lower skin.

The color scan which followed the repair confirmed the void. To visually assess the problem, an oval section of skin was removed (fig. 14). Further examination disclosed that those areas adjacent (in the spanwise direction) to the initial void were also voided or weakly attached. Progressive removal of the entire lower skin was successfully accomplished (fig. 15). An entire new lower skin was successfully bonded to the spoiler frame, with the subsequent NDT inspection showing a void-free bondline. Following the repainting and reinstallation of details, the spoiler was returned to service.

*Figure 14.—Skin Removed From S/N 0024*

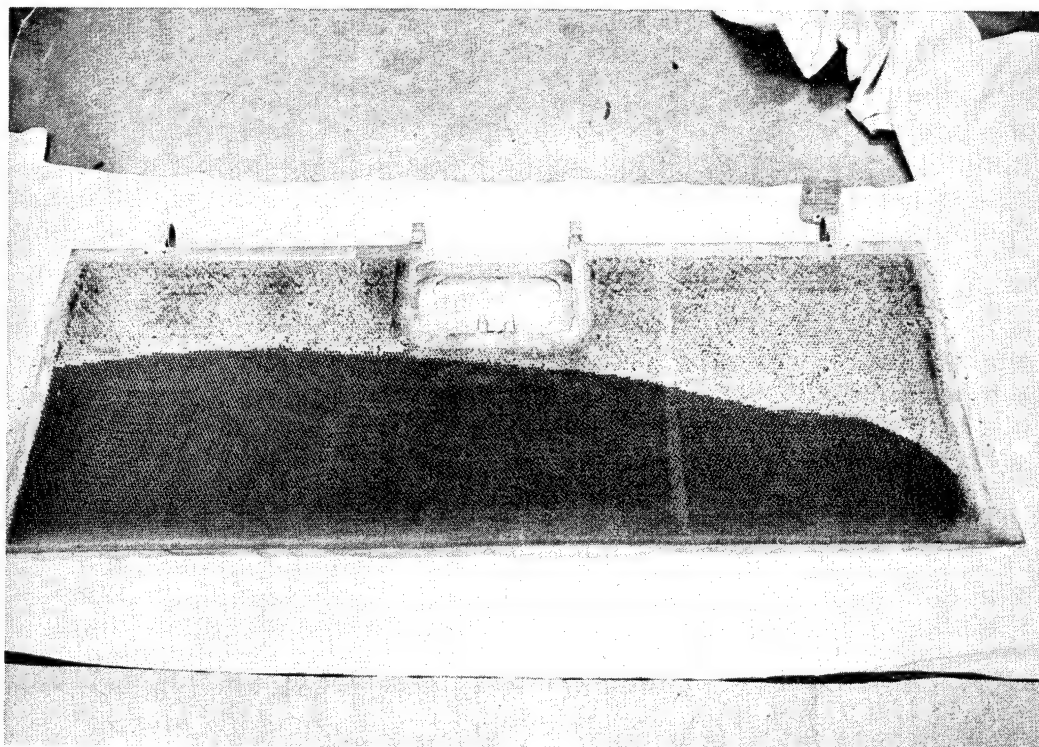
*Figure 15.—Lower Skin Completely Removed From S/N 0024*

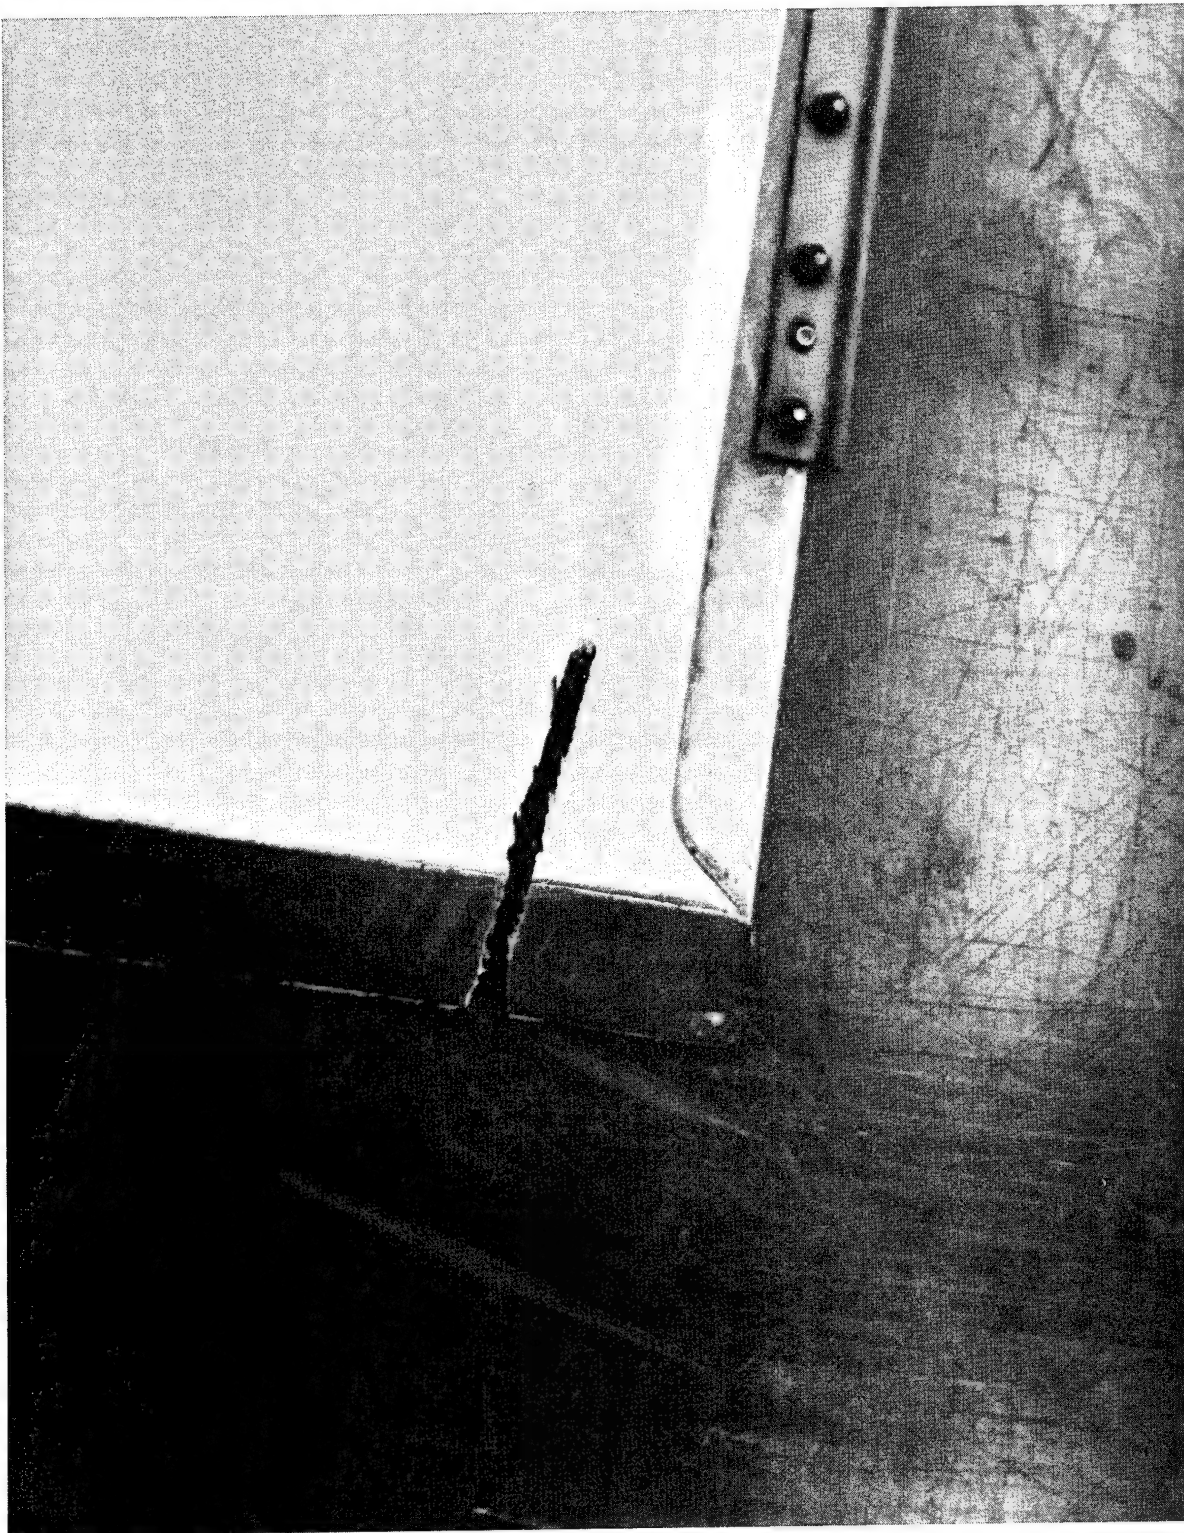
In June 1974, New Zealand National Airways reported that spoiler S/N 0089 had been inadvertently damaged by a control cable during aircraft overhaul. The nature of the damage was a slot cut through the spoiler thickness for a length of approximately 6.6 cm (2.6 in.) from the trailing edge. This damage has been repaired by Boeing, and the spoiler has been returned to National Airways and reinstalled.

*Figure 16.—Damaged Trailing Edge of S/N 0089*
